Manhole Inspection Summary

Manhole # S35G__030MH

Insp Date: **10/29/08 1:35 PM**

Location Address: **e lombard st**

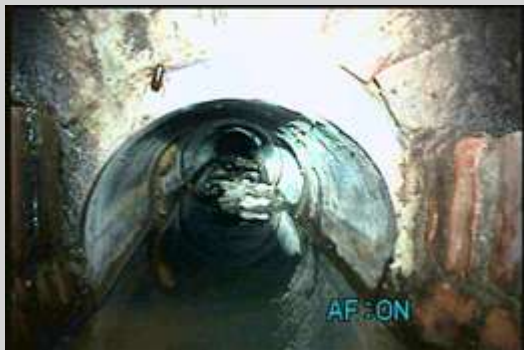
12 O'Clock Outflow

10 in. Circular Gravity Sewer
Pipe Out @ 12 O'Clock

Pipe Material: **Clay** ☐ Pipe Lined

Invert Depth: 11.50 (ft.) Flow Characteristics: **Slow**

Deposits: ☒ None ☐ Mud ☐ Sludge ☐ Debris ☐ Grease

Infiltration: **None** Pipe Seal Cond: **Unknown**

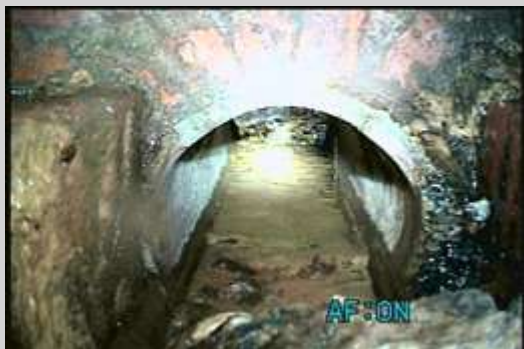
6 O'Clock Inflow

10 in. Circular Gravity Sewer
Pipe In @ 6 O'Clock

Pipe Material: **Clay** ☐ Pipe Lined

Invert Depth: 10.66 (ft.) Flow Characteristics: **None**

Deposits: ☒ None ☐ Mud ☐ Sludge ☐ Debris ☐ Grease

Infiltration: **None** Pipe Seal Cond: **Unknown**

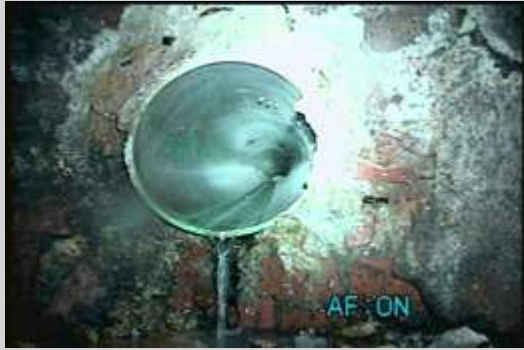
7 O'Clock Inflow

8 in. Circular Gravity Sewer
Pipe In @ 7 O'Clock

Pipe Material: **PVC** ☐ Pipe Lined

Infiltration: **None** Pipe Seal Cond: **Unknown**
